ENHANCED PRELIMINARY ASSESSMENT REPORT:

JEFFERSON PROVING GROUND
MADISON, INDIANA

March 1990

Ebasco Environmental
5000 Bradenton Avenue
Dublin, Ohio 43017

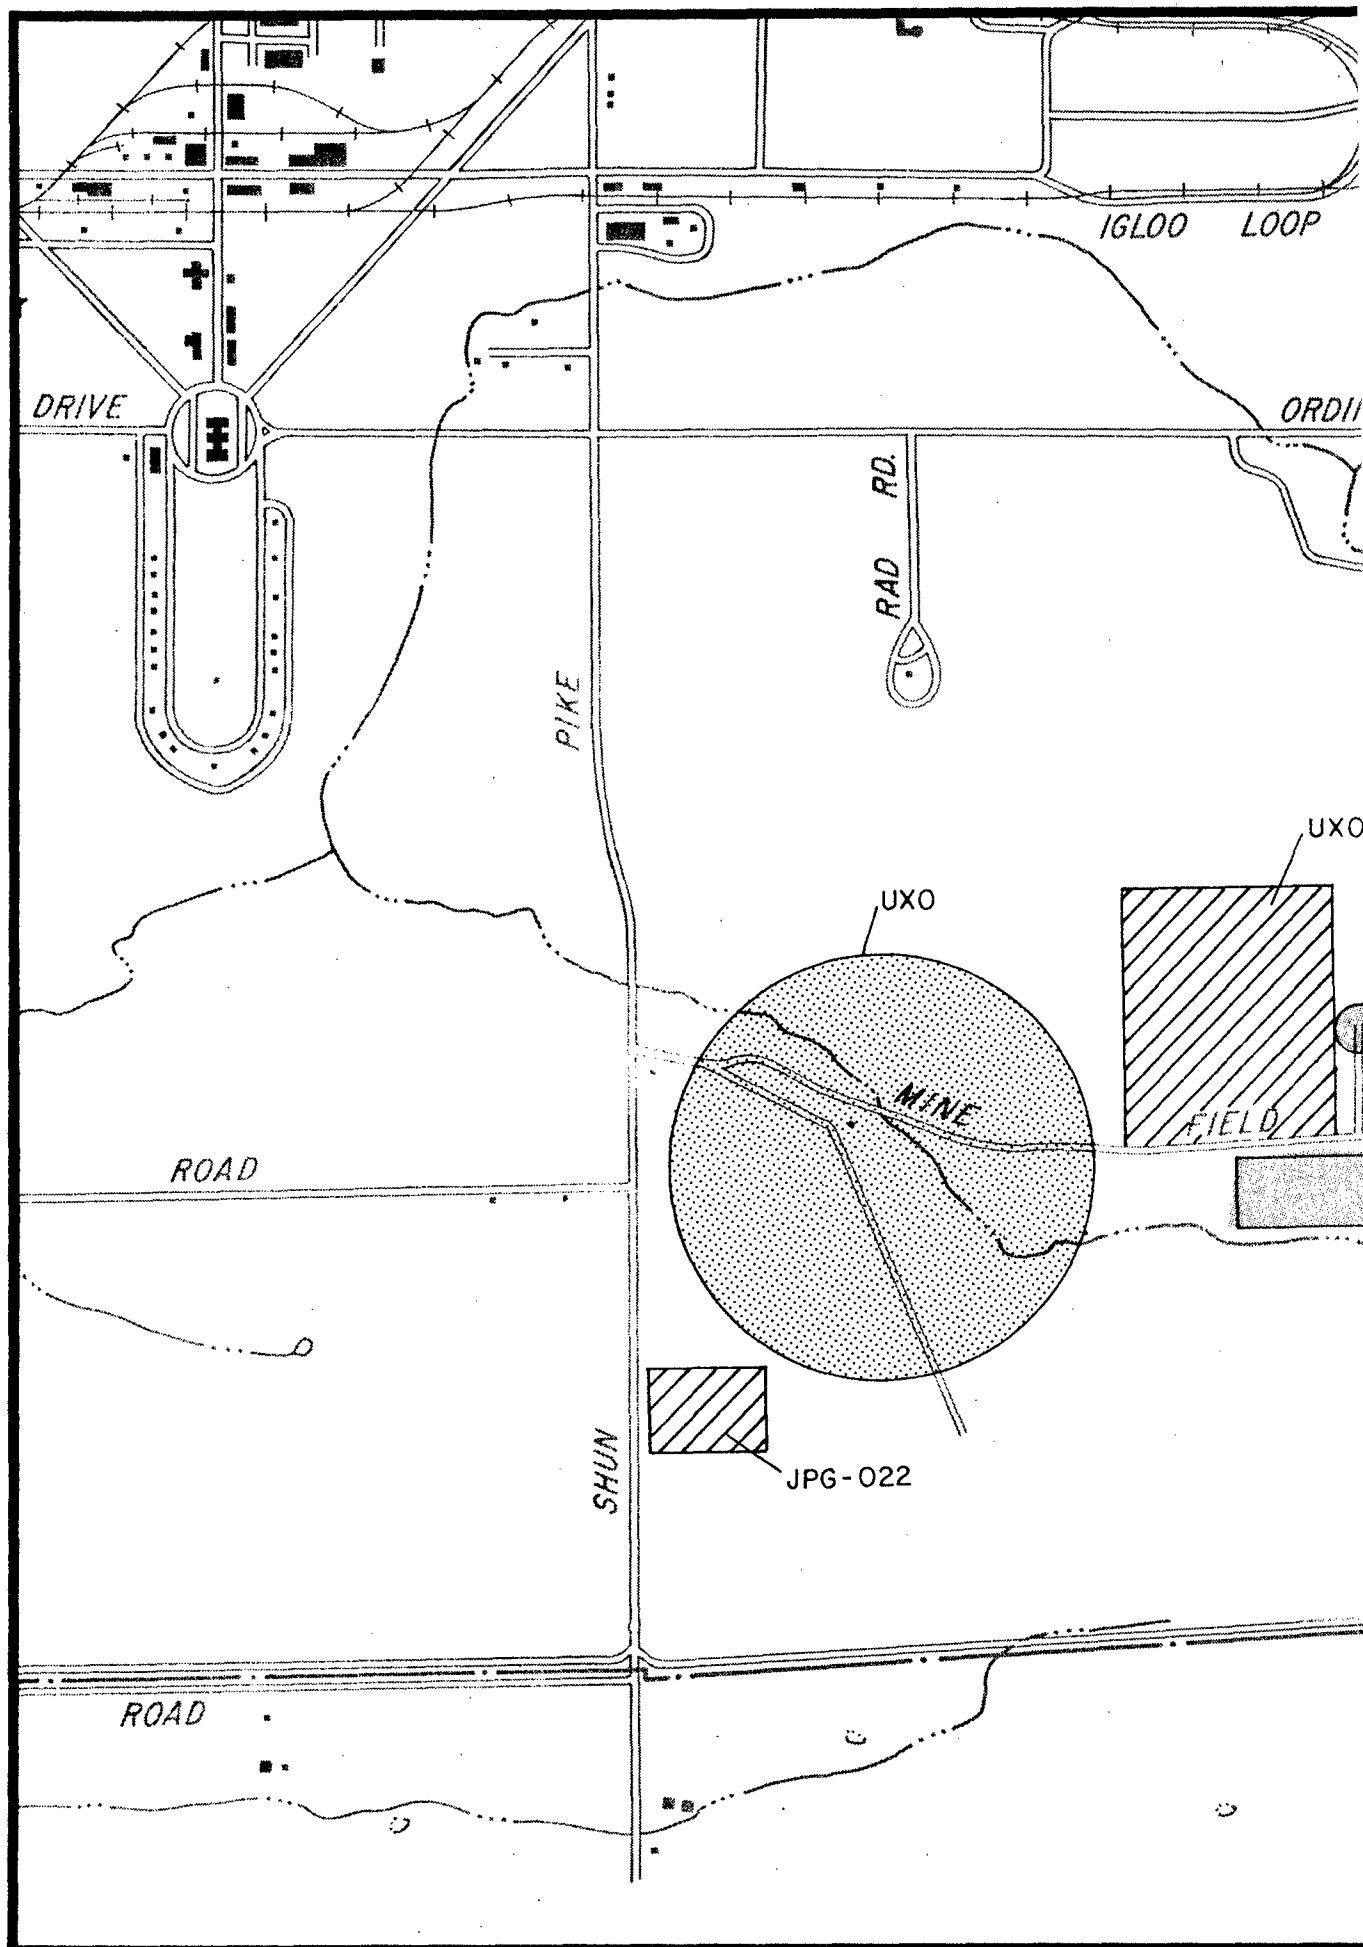
FIGURE 6

JPG-022 is a thermal treatment area which has been in use since October 1986 (Figure 6). The site operates under RCRA Interim Status for open burning. The open burning area is an open field with secured gates placed far enough away from the burning area to prevent unauthorized access. The four (4) burning trays utilized at this site are constructed of heavy steel with dimensions of 5 feet x 15 feet x 1 foot in depth. The trays have removable locking aluminum covers, and have ports for the drainage of collected rainwater. The areas on both sides of each burning tray have been cleared and graded. This site is utilized for the open burning of waste and unused/unusable propellant deemed unsafe to dispose with incineration (reportedly, 60,000 lbs. per year). The most common material burned is nitroguanadine.

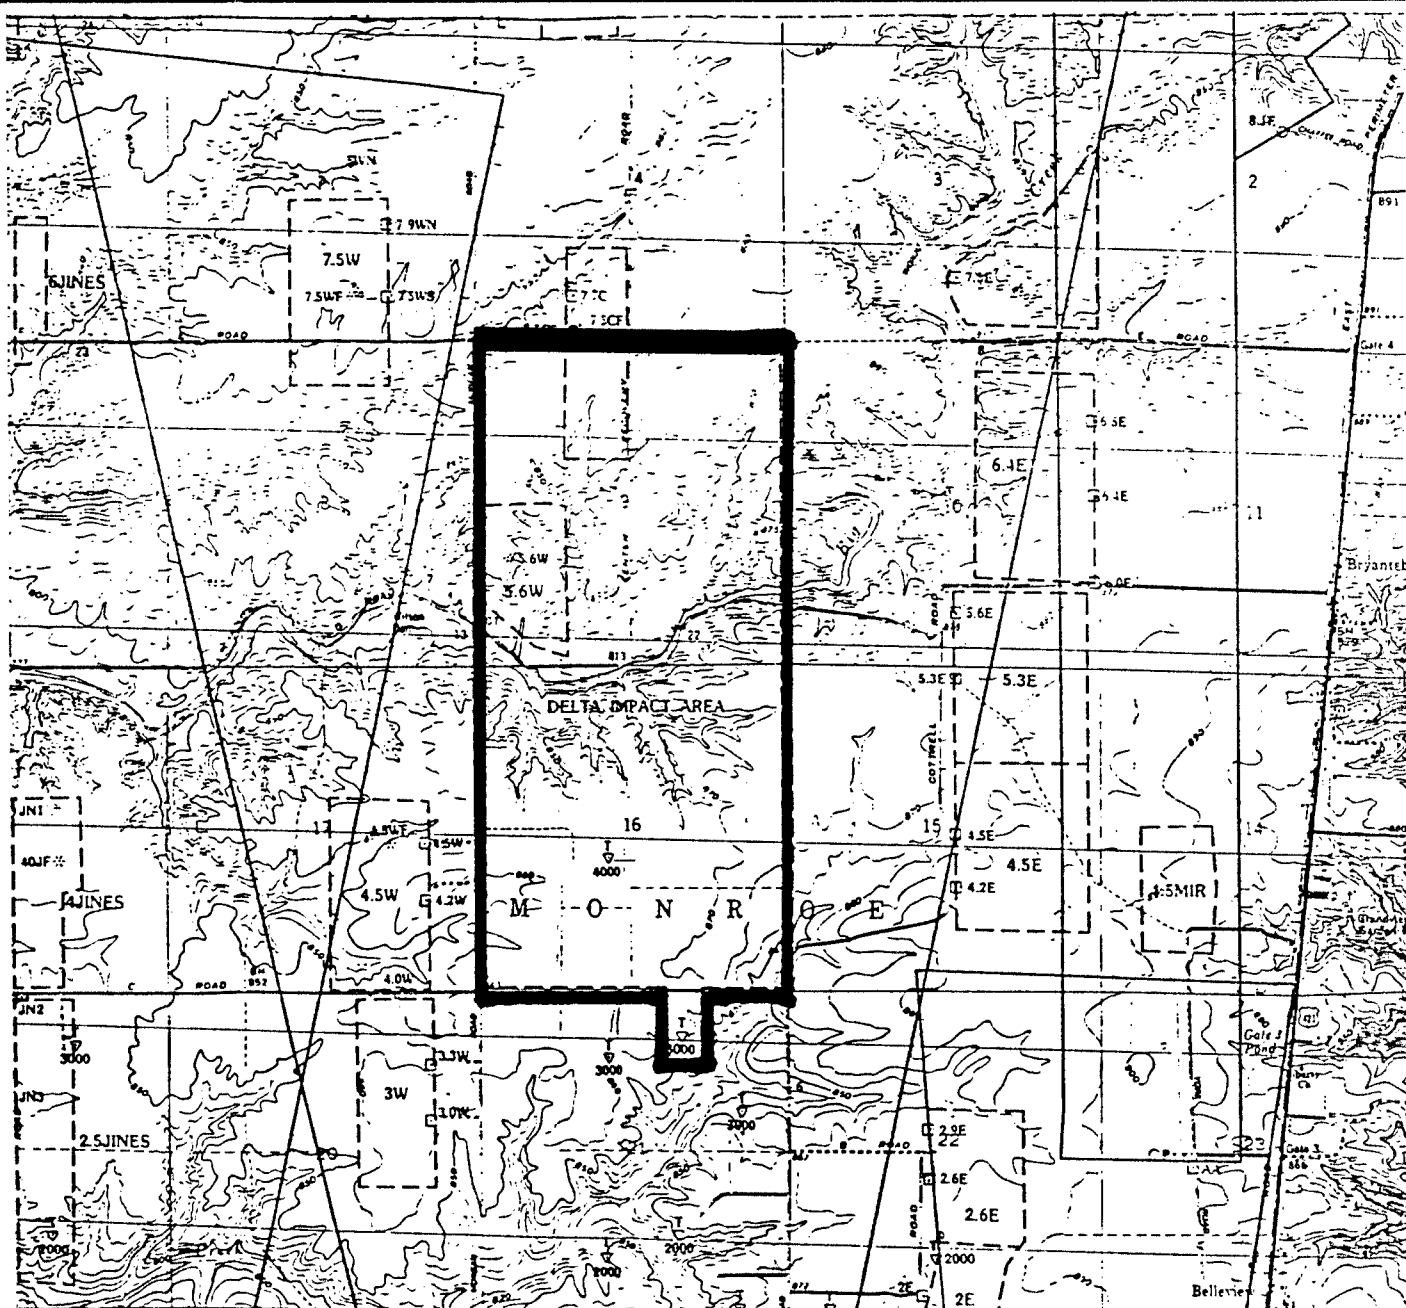
EBASCO ENVIRONMENTAL
FIGURE 10
Depleted Uranium Impact Field

Depleted uranium (DU) rounds are fired north of the firing line (Figure 9). More than 60,000 kg of low-level radioactive depleted uranium penetrators were fired on a 2-square mile area (Figure 10).
